STATE OF MARYLAND
DEPARTMENT OF TRANSPORTATION
STATE HIGHWAY ADMINISTRATION
OFFICE OF TRAFFIC & SAFETY
TRAFFIC ENGINEERING DESIGN DIVISION
MD 542 (Loch Raven Blvd) and Goucher Boulevard
Loch Raven, MD

APPROVALS		REVISIONS		TRAFFIC SIGNALIZATION PLAN	
TEAM LEADER		①	UPGRADED TO VIDEO DETECTION AND REPLACED DETECTION DUE TO RESURFACING. SHA. NO. B48695177 TIMSR J416 3/01/2011	SCALE 1" = 20'. ADVERTISED DATE 8/01/1984 CONTRACT NO. _____	
ASST. DIV. CHIEF		②	ADDED PED POLE AND SIGNAL NO. 3 FOR LEFT TURN B-785-501-485 6/07/1986	DESIGNED BY B. Thompson COUNTY Baltimore	
DIVISION CHIEF		③	CHANGED DETECTOR TO DELAY OUTPUT 4/05/1986	DRAWN BY B. Thompson LOGMILE _____	
OFFICE DIRECTOR				CHECKED BY D. Doda TMS NO. _____	
				F.A.P. NO. _____ TOD NO. _____	
				TS NO. 2009C	DRAWING TSP-2 OF 5 SHEET NO. 252B OF 301

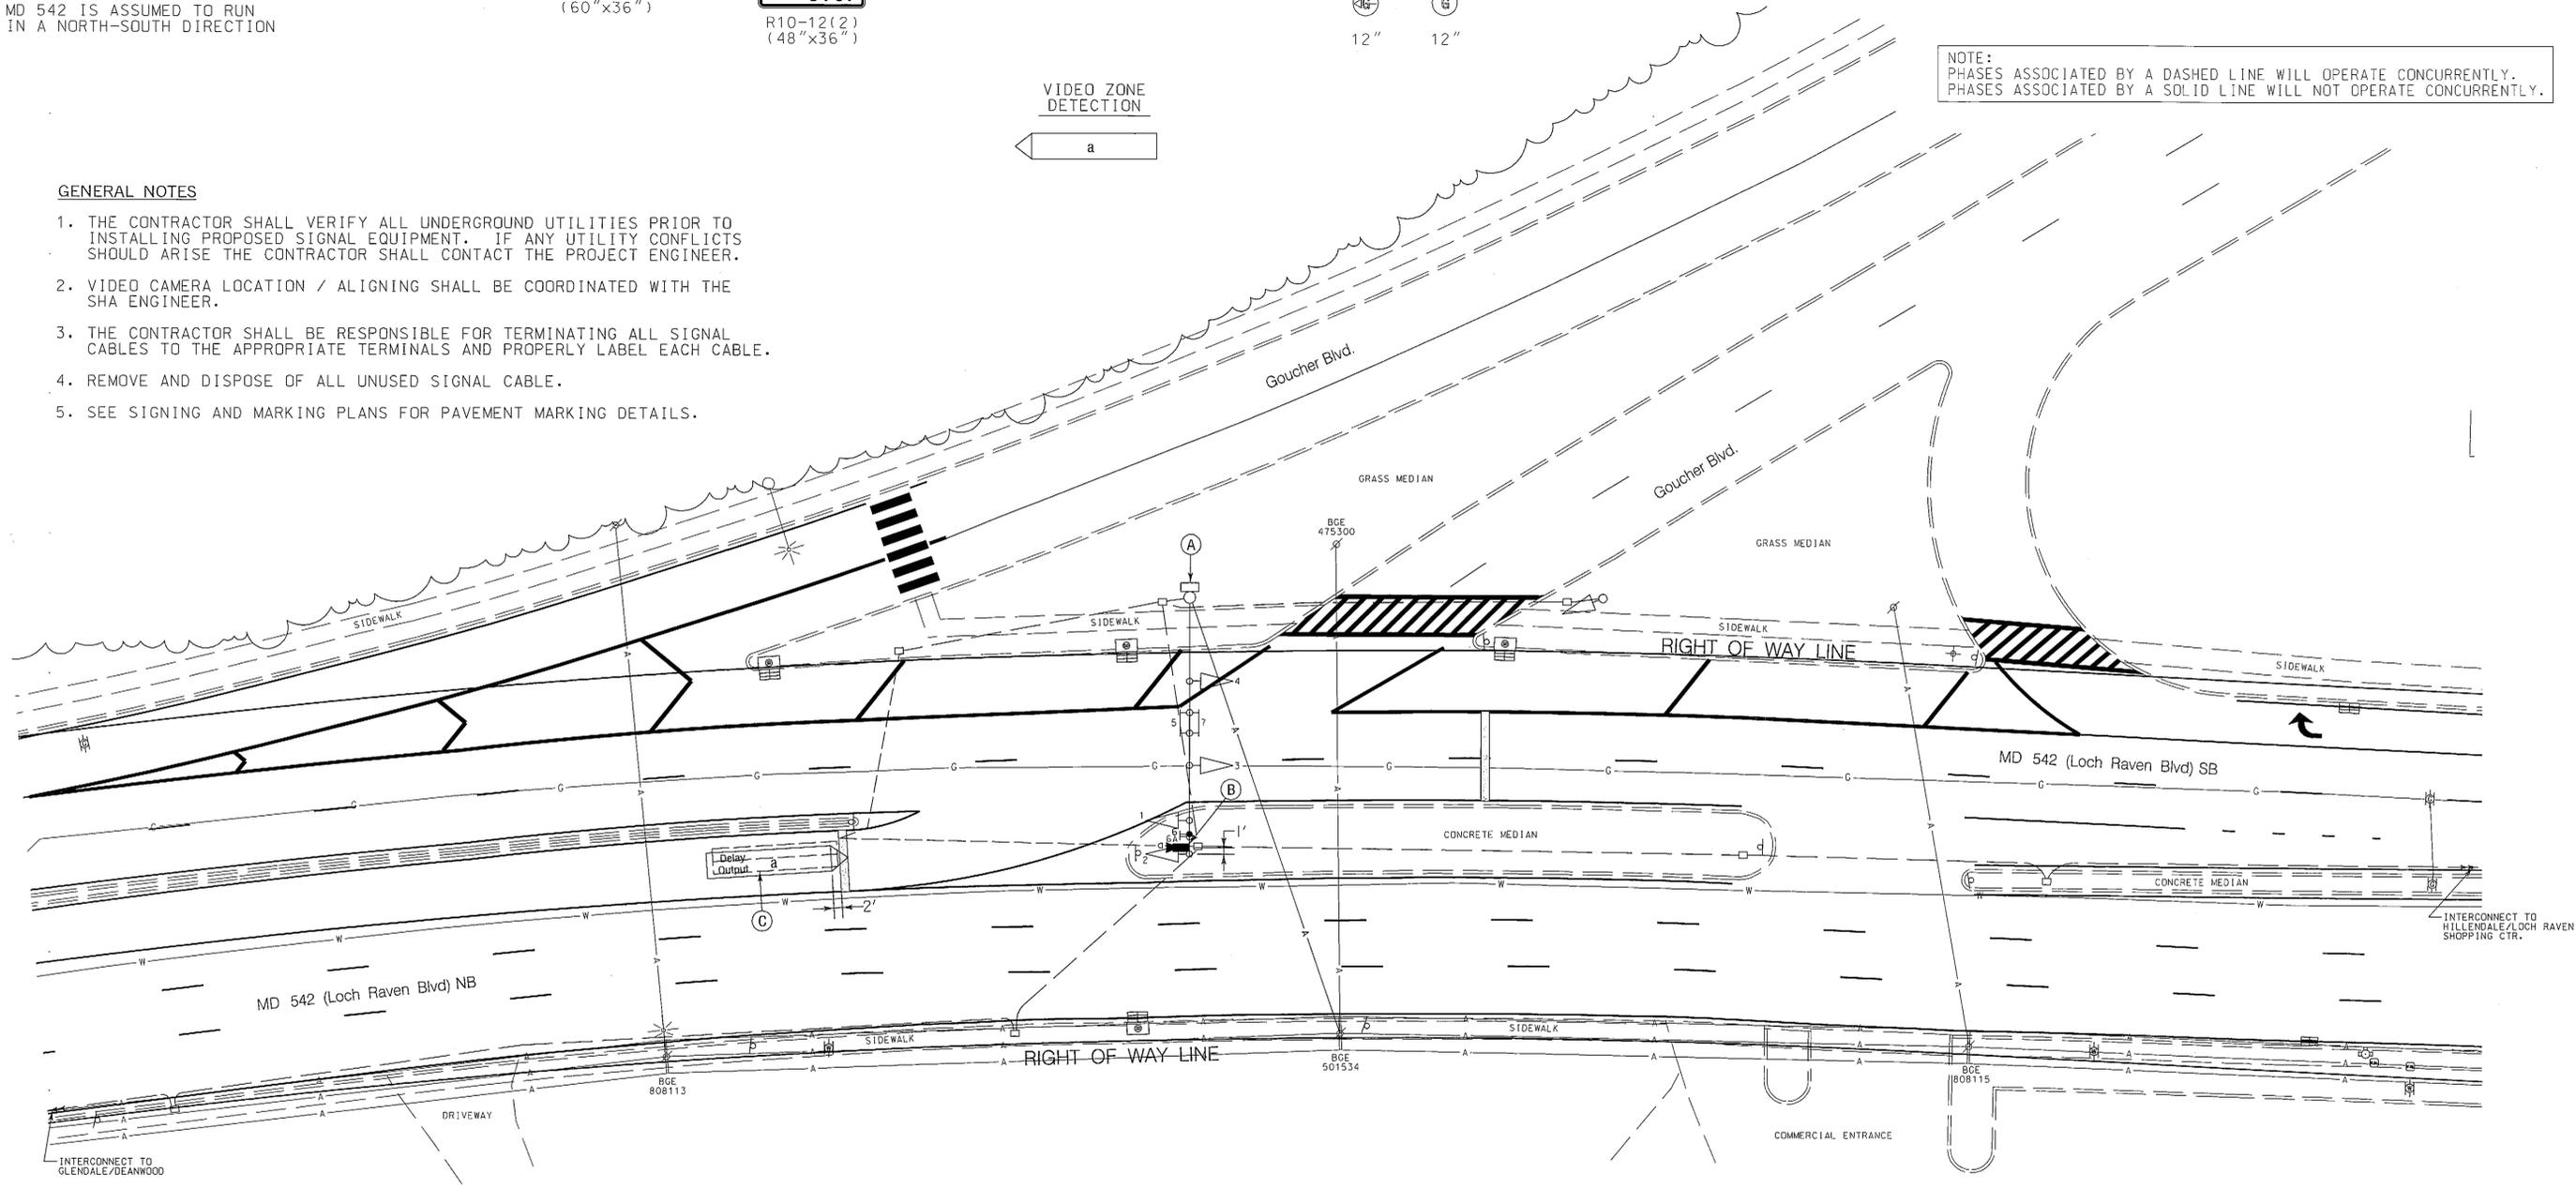
MD 542 IS ASSUMED TO RUN IN A NORTH-SOUTH DIRECTION

PROPOSED VIDEO DETECTION CAMERA

VIDEO ZONE DETECTION

CONSTRUCTION DETAILS

- A. USE EXISTING POLE MOUNTED CABINET AND CONTROLLER. (NOTE: SHA FORCES SHALL RETROFIT CONTROLLER EQUIPMENT TO OPERATE VIDEO DETECTION EQUIPMENT).
- B. USE EXISTING MAST ARM. INSTALL NEW OVERHEAD VIDEO DETECTION CAMERA ON MAST ARM, REMOVE EXSTING SIGN AND INSTALL R10-12(2) SIGN AS SHOWN.
- C. ABANDON EXISTING LOOP DETECTOR. DISCONNECT AND REMOVE LOOP DETECTOR CABLES FROM CONDUITS, HANDHOLES, SIGNAL STRUCTURES AND CONTROLLER.
